What happen in GEM module ?

What we found through investigations

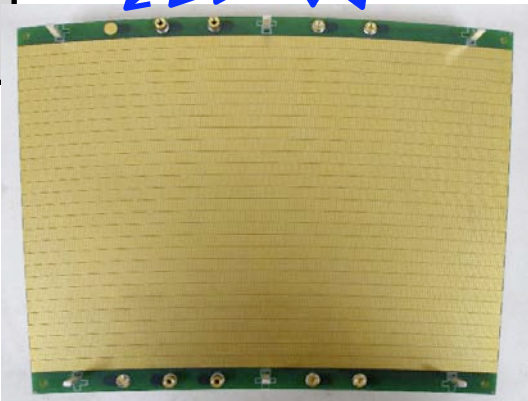
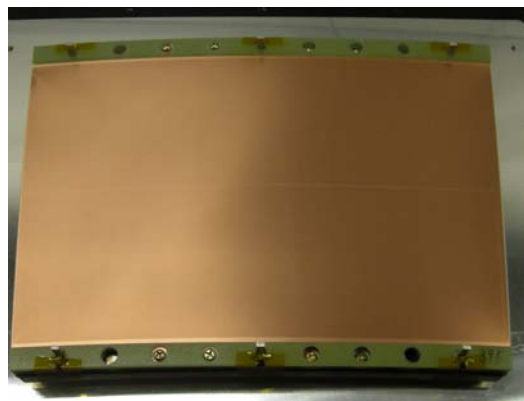
HV connection of GEM module/LP1

Gate is terminated to GND through $M\Omega$ res.
w/o HV connection

hight of Gate surface is 500um above dummy insulator beyond over dummy

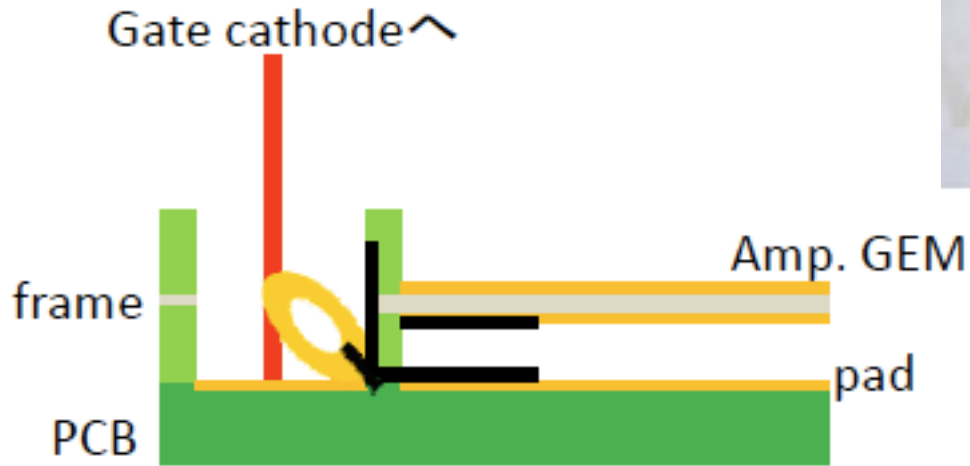
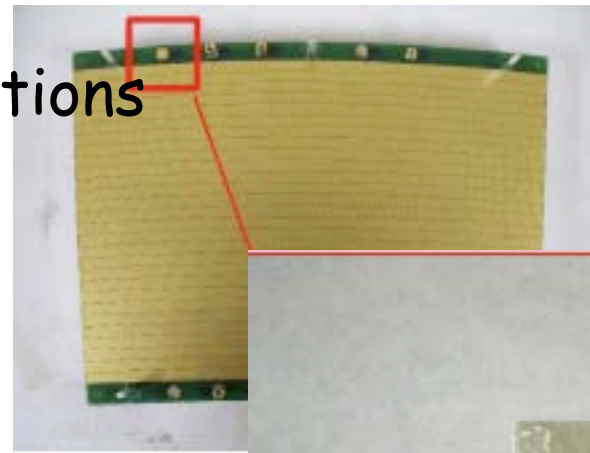
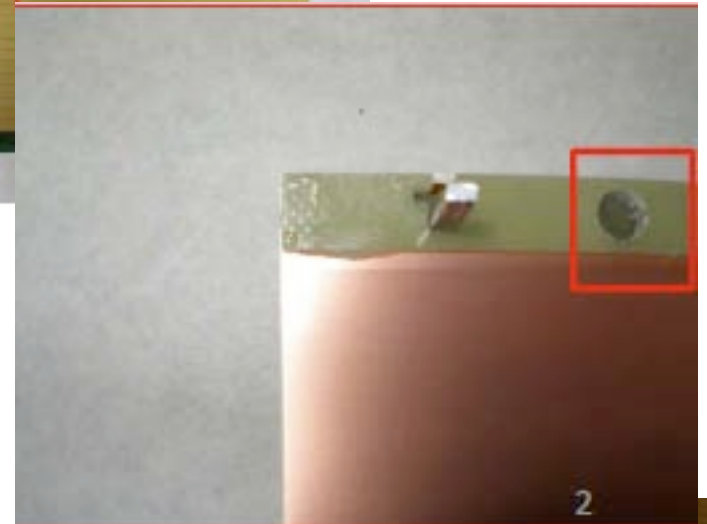
HV connection problem happen last time
solution => put Cu washer at HV - GEM connection

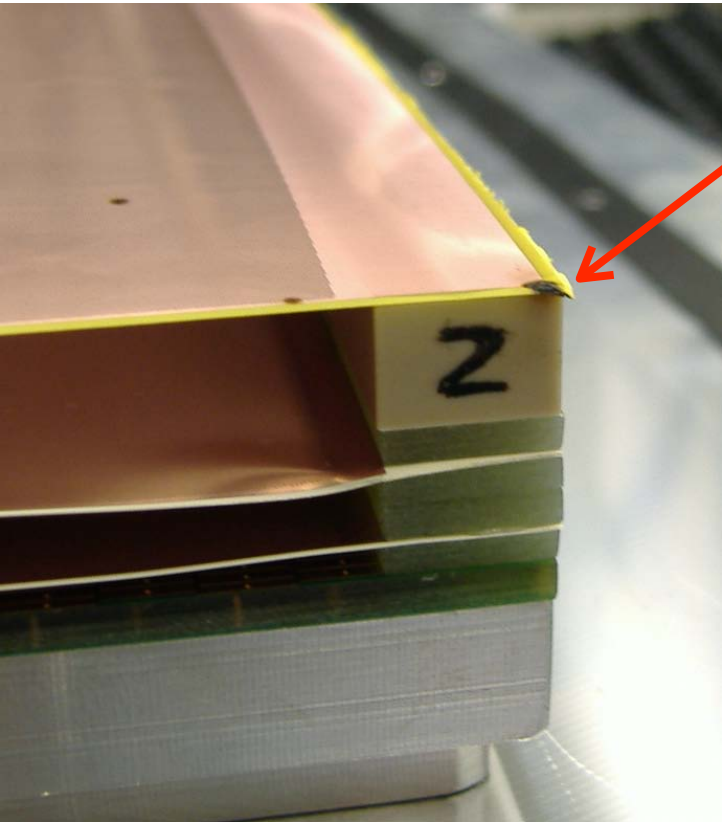
discharge at Gate surface

When HV trip, discharge may happen because Gate electrode is too close to Dummy surface over placed insulator help discharge

Chronological order is not proved
