# Quality control of copper plating for coupler

LCWS13 at Tokyo, November 12, 2013

Nomura Plating Co., Ltd

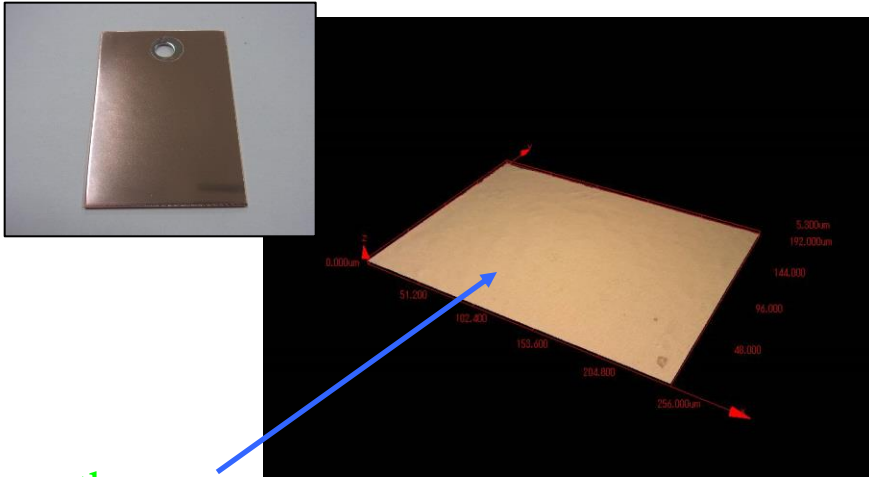
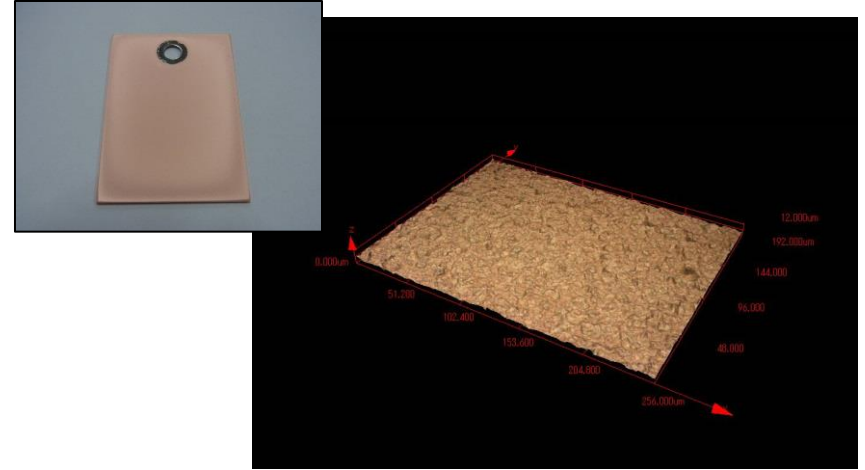
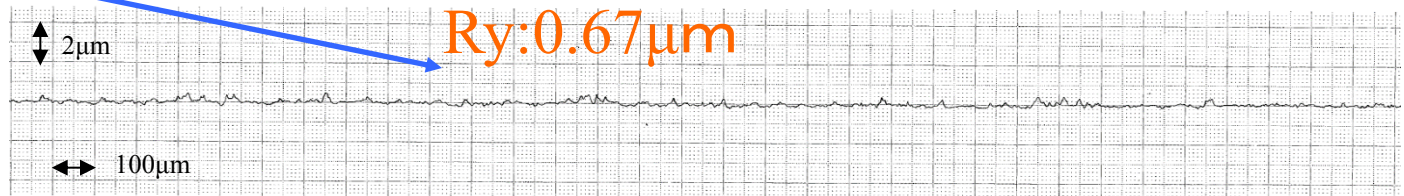
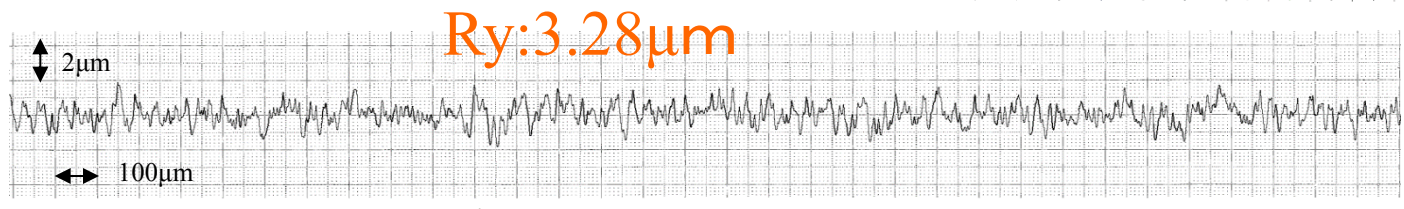
## 1.2 Surface roughness of copper coating

Those figures show surface observation by laser microscope and profiles of the coating roughness by profilometer after copper plating. **Copper pyrophosphate** plating has **smoother** surface than sulfate plating.

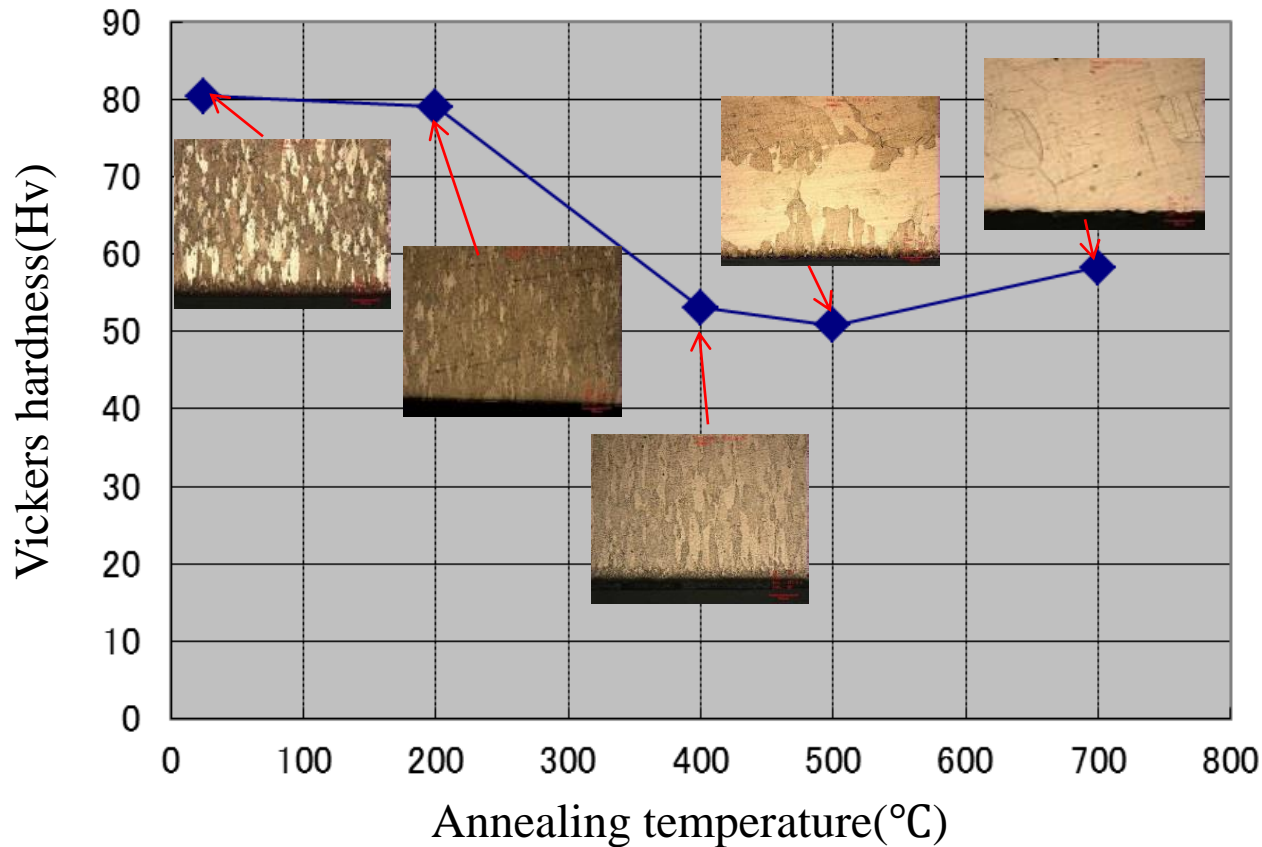
## 1.3 Grain structure and hardness of copper coating after annealing

This figure shows a **cross-section micro grain structure** and **hardness** of the copper coating from **pyrophosphate** bath after annealing at various temperatures. The **grain size** grows with increasing temperature. This is consistent with changes in hardness.

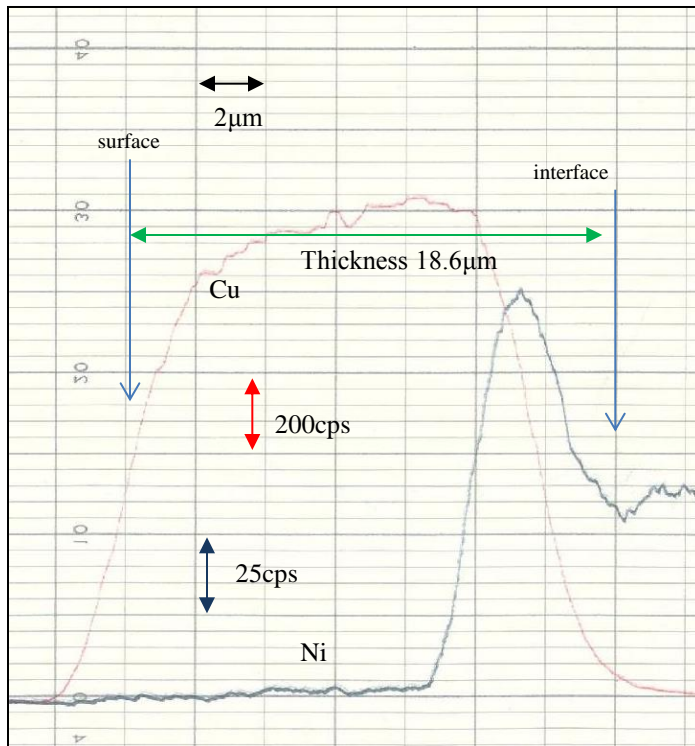
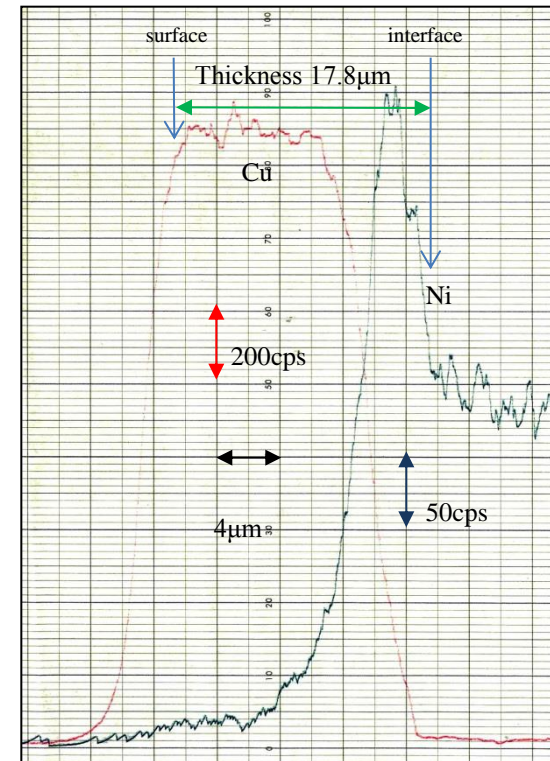
Strike nickel plating film is diffused into the copper coating in **the brazing process** (conditions: hydrogen furnace, 800 °C, 10min), but strike **nickel** plating was **remained** sufficiently near interface between work and copper coating.

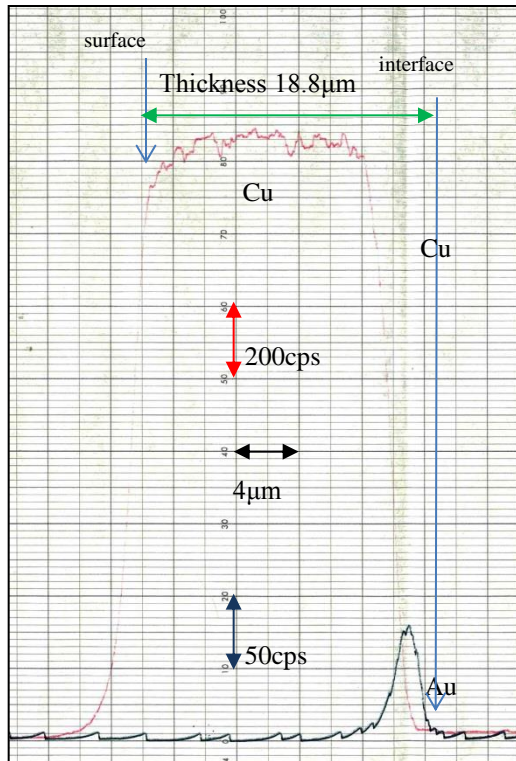
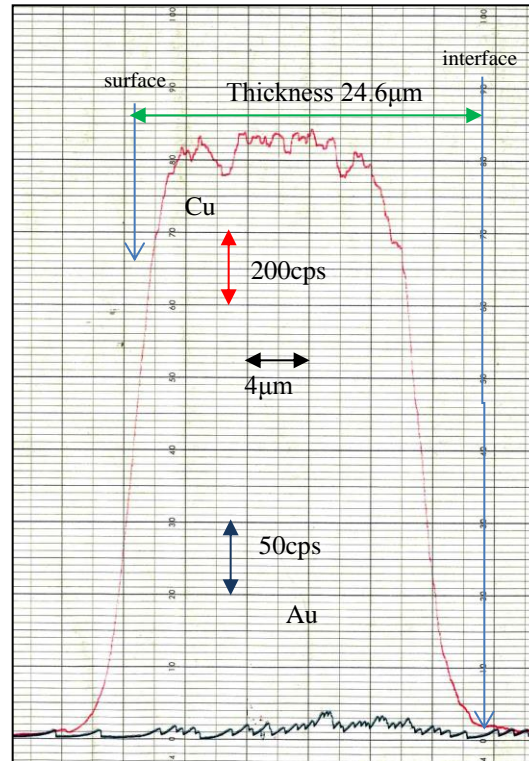
## 4.2 Diffusion of strike gold plating

Strike gold plating film is diffused into whole of copper coating in **the brazing process** (conditions: hydrogen furnace, 800 °C, 10min), strike **gold** plating film was **not remained** sufficiently near interface between work and copper coating.
