Challenges and Status of XFEL

Attempted Outline

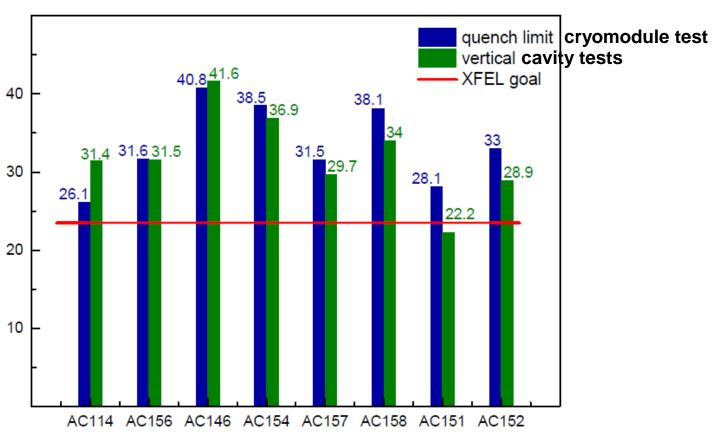
XM-3 RF Test Results

Gate valve	CV 1	CV2	CV3	CV4	CV5	CV6	CV7	CV8	BQU		
	AC114	AC156	AC146	AC154	AC157	AC158	AC151	AC152			
Eacc (VT)	31,4	31,5	41,5	36,9	29,7	38,8	22,2	28,9			
Fe limit (VT)	31,4	31,5	41	36,9	29,7	38,8	16,8	20		229,6	MV
CMTB	23,2	31,4	40,8	38,5	_31,5	38,1	- 22,7	33		231,8	MV
										29,0	MV/m
		-		-

- ✓ Seven cavities are reproducing VT gradient
- ✓ The cryomodule reproduces gap of 230 MV
- ✓ Cavity 1 is degraded from 31 down to 23 MV/m useable gradient: gate valve/cav1 connection not for training!
- ✓ Qualifies CEA assembly team (100% string assembly by CEA), procedures and partially the production tool (ISO4 clean room, DESY pumping units, 3 mobile clean rooms, procedures, big tools)
- ✓ The clean room vacuum system was not complete (CEA cavity venting on rails)
