High pressure rinsing stand at DESY

HPR at DESY

actions on the system since installation

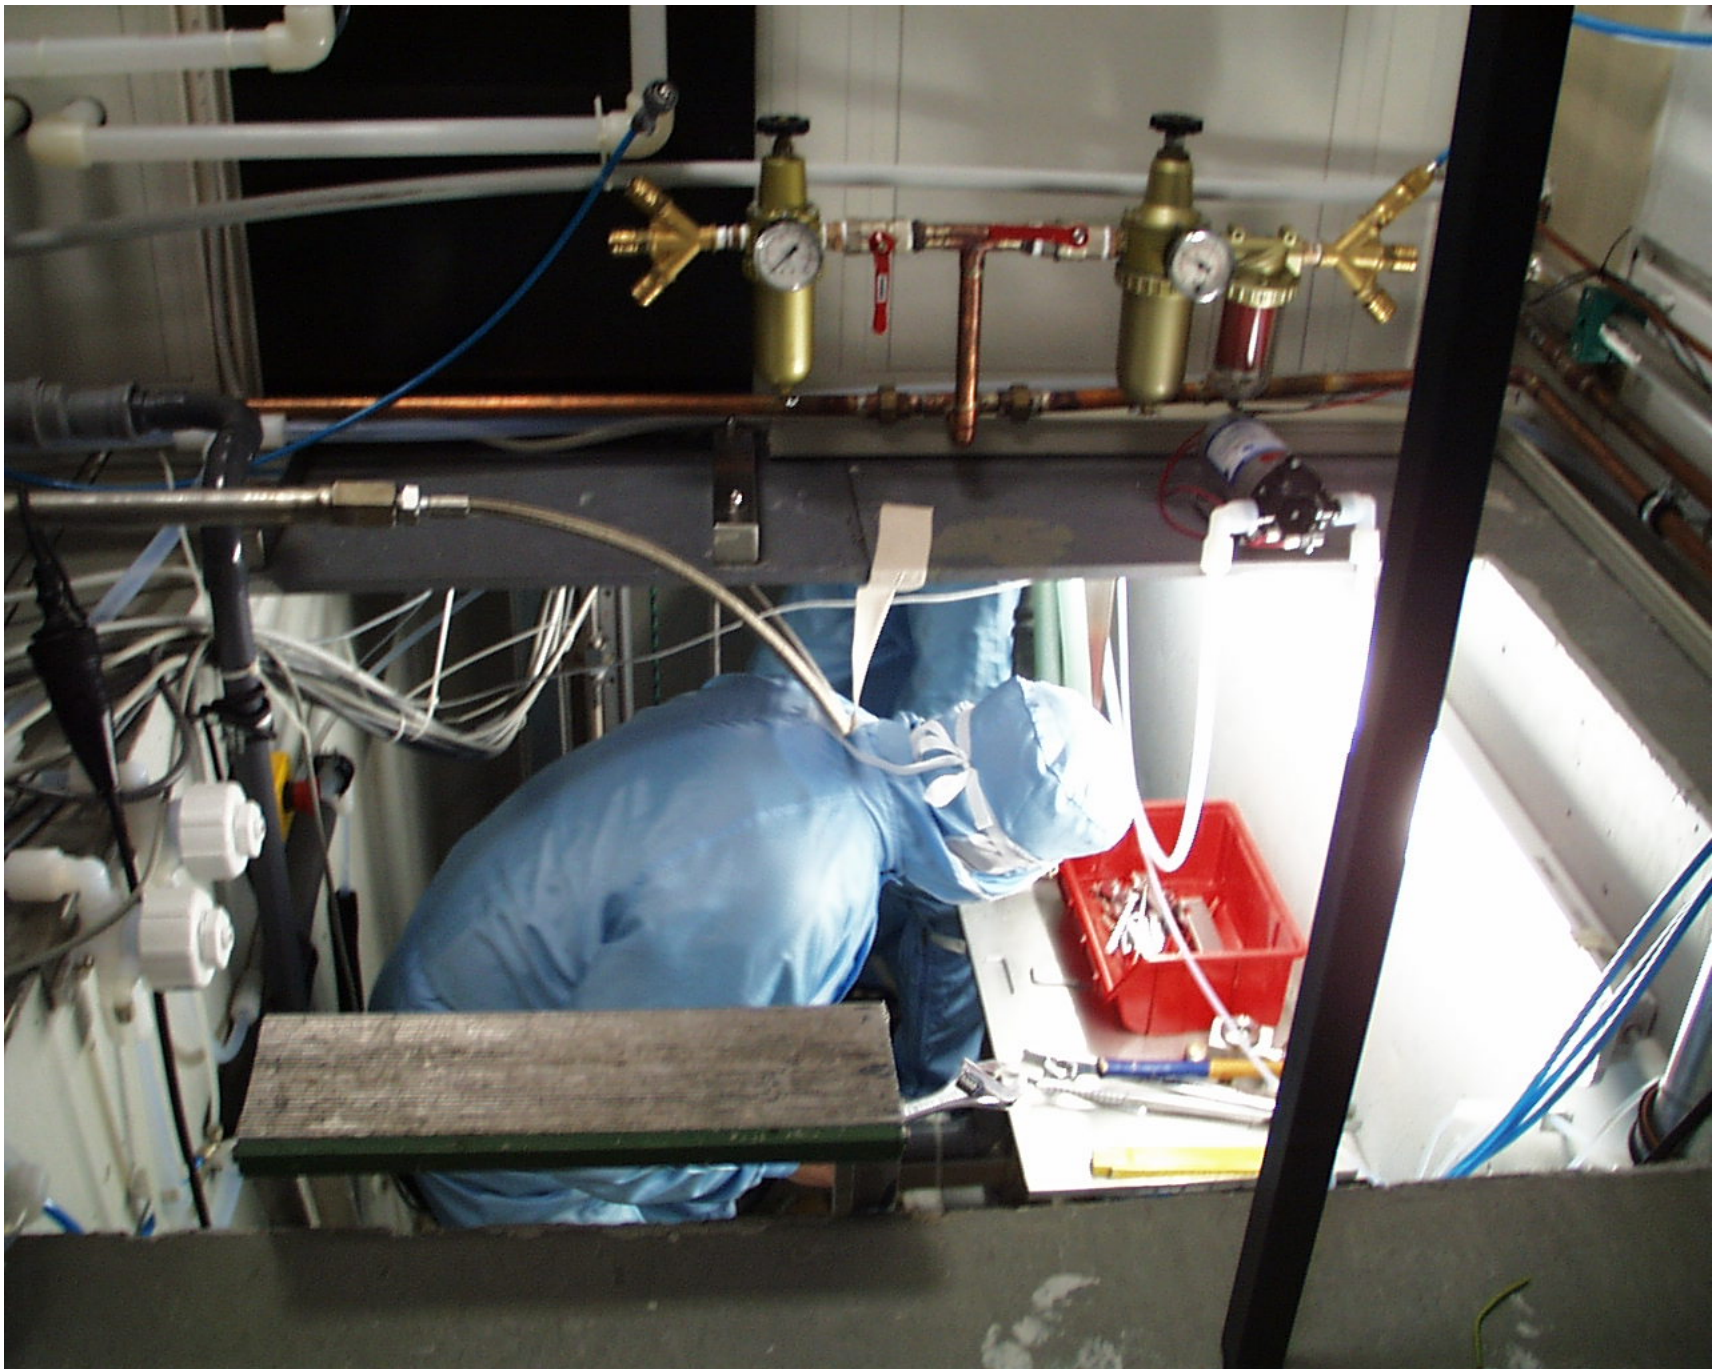
- **Bearings of cavity table and housing rusty**
(exchanged to stainless with sealed greasing area)
- **Housing ventilation installed** (measurements showed calls 10000 inside)
- **Chain and chain wheel Not lubricated** (particulates / renewing)

- **Rotational bearing Platform to cane crashed** (badly lubricated by water)
- Residues from PTFE / guidance on inner cane
- Sealing ring abrasive (particles on cane)

- Cane tube leaking no repair possible
- N2 Overlay filter blocked by water (general design)
- **Valves behind filter unit** (changed =only Inner cane has 0,02 µm filter)
- Vale leaking / blocking

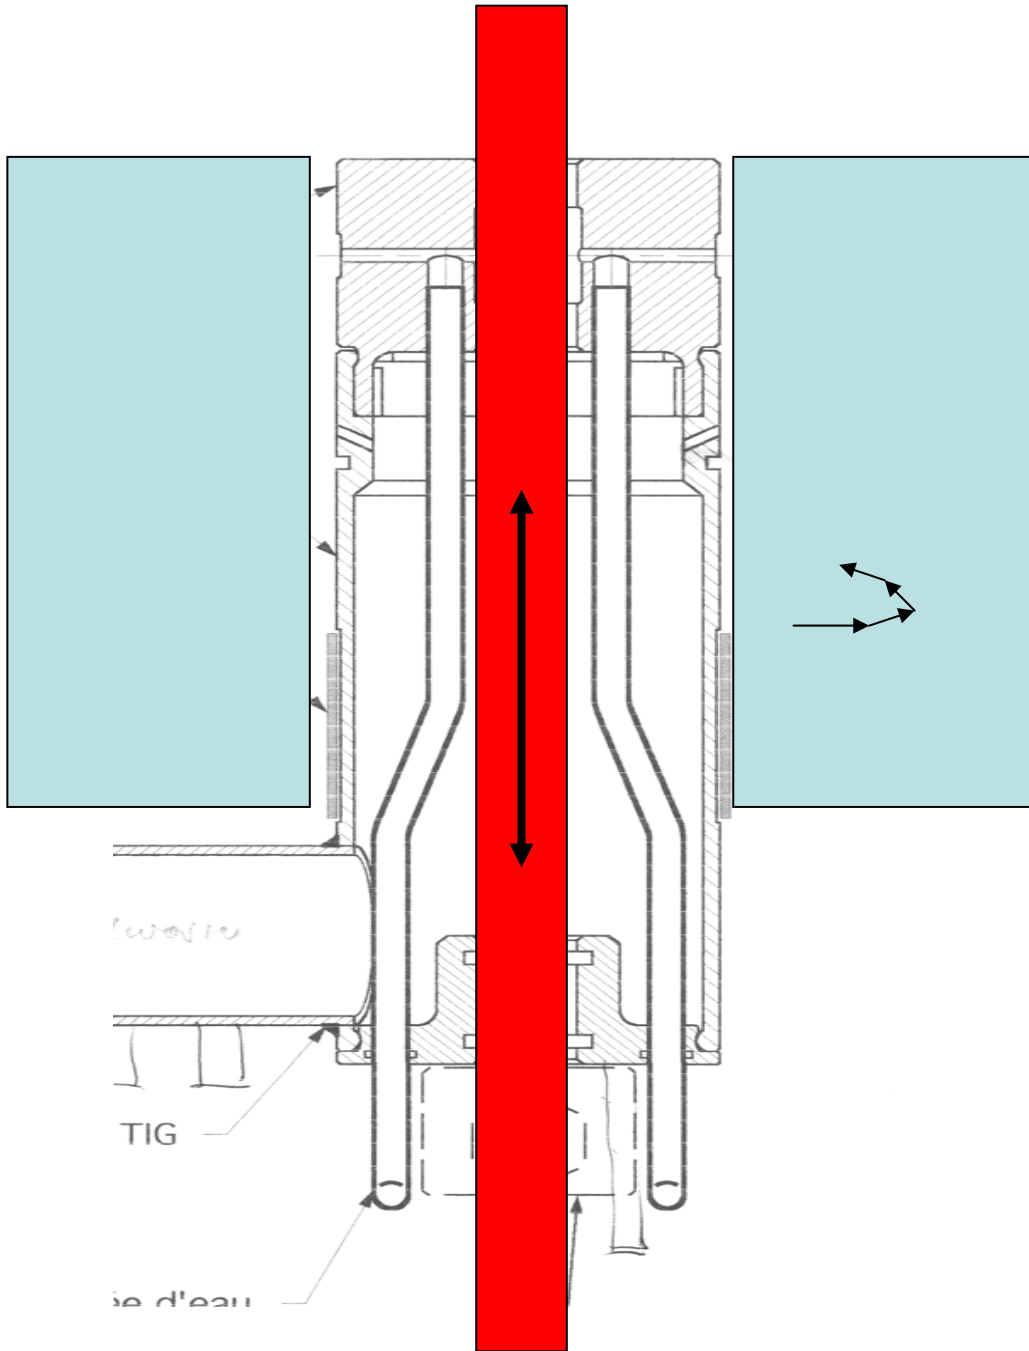
Main design draw back

- Minimum death volume
- Cutting of cone on place
- Cutting of threads on place
- Alignment of elements critical
- Material combination stainless on stainless

General design problem.

- Cane rests in gray room interior (moves into cavity)
- Moving cane need seal (platform for filters; valve; mechanics and sensors in water)
- Bearing for cane and cavity table movement combined
- N2 filter unit installation filter lowest point in tube
- Water lines can not be drained Draining of tubing (inner cane has standing water
- Rust in 100 bar line elements / non lubricated parts cracked during disassembly
- Excess for maintenance
 - change cane seal means complete dismounting of rinsing unit!!
 - Rinsing for weeks to clean)
- insertion of cavity (abrasives form post and frame)
- Airflow inside HPR cabinet
- Alignment of cane (bottom platform underground cane top in class 10)

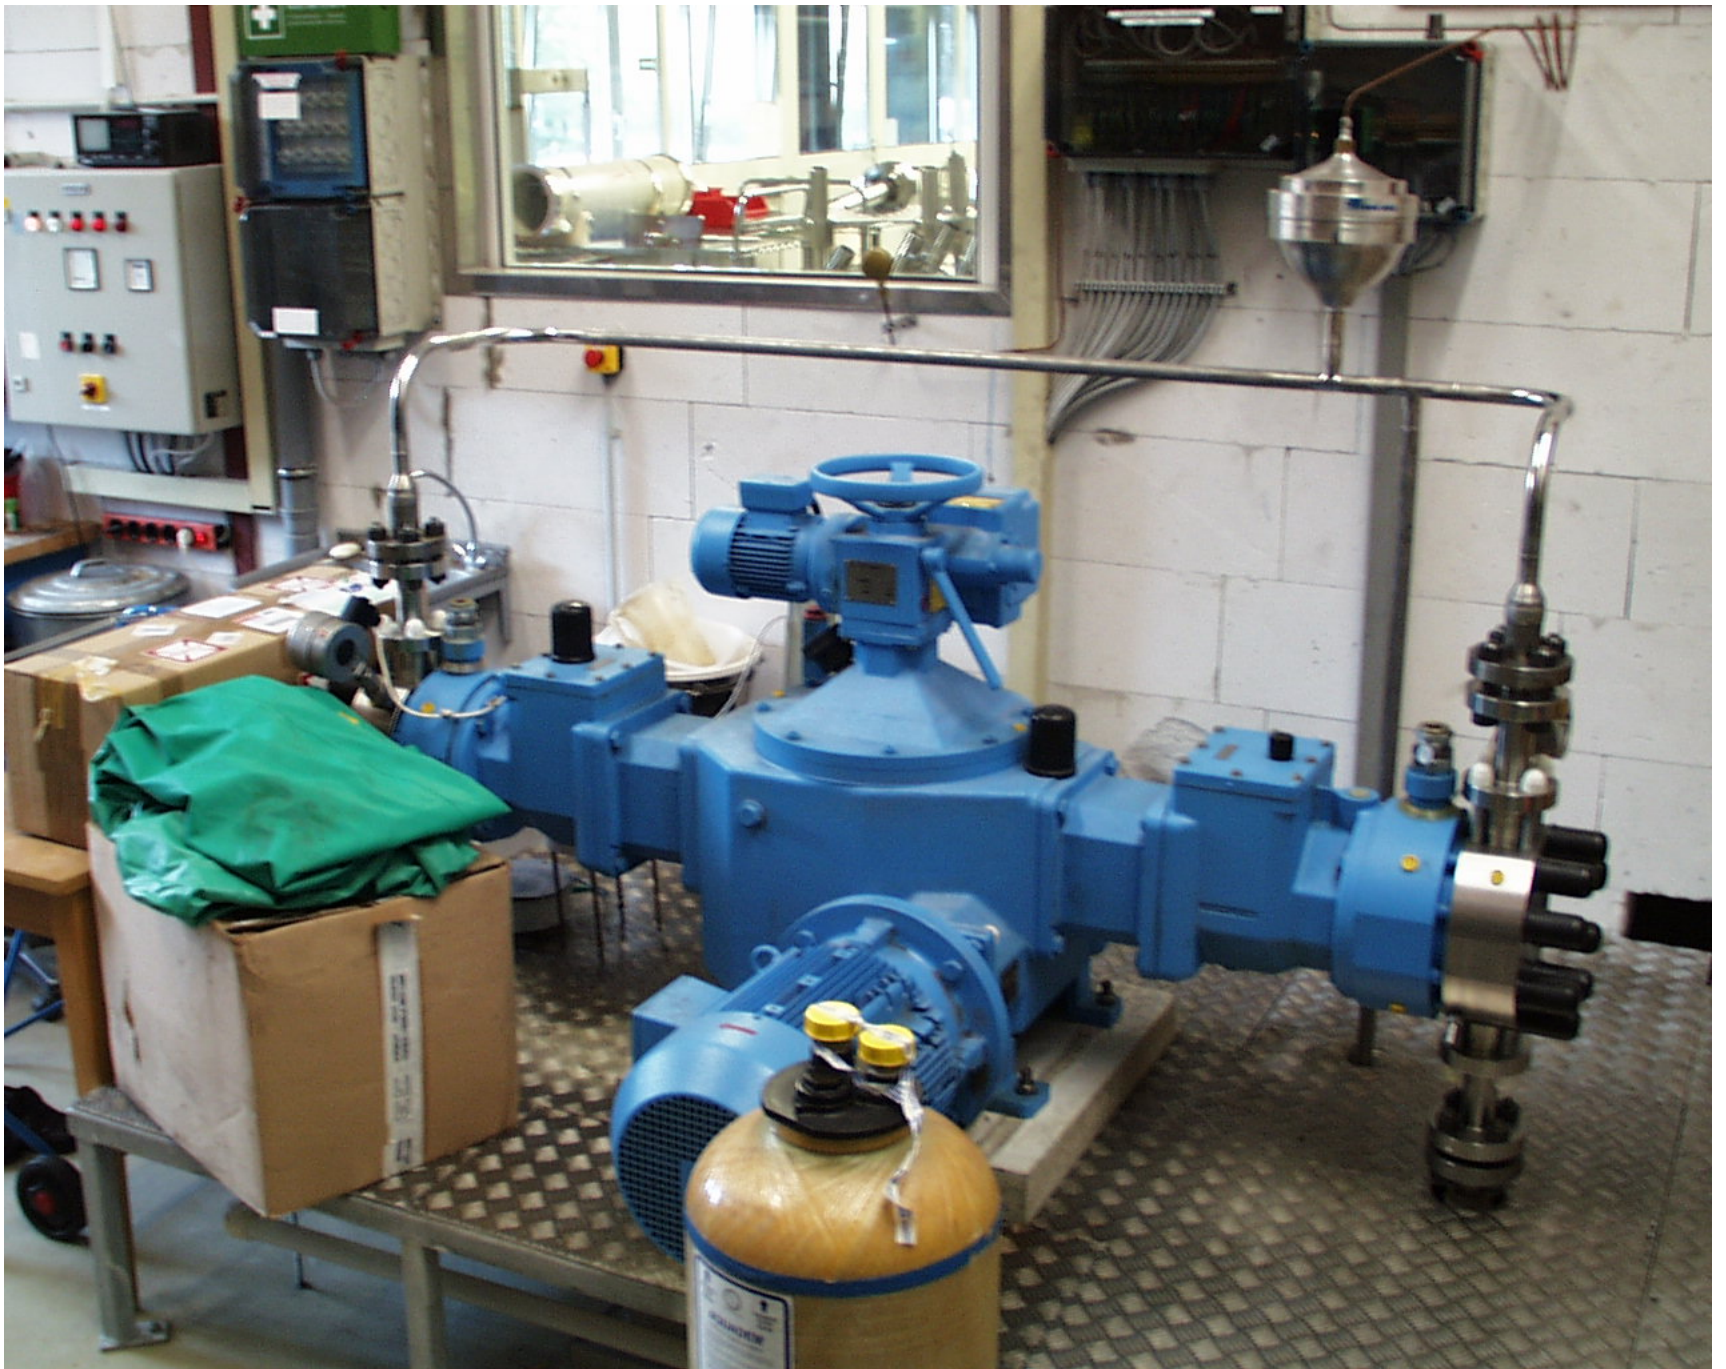
Failure on HPR equipment

- Membrane of pumps broken (programming and restart procedure of pump)
 - organic oil inside HPR tubing
- Valves blocked (pump running condition)
- N2 overlay blocked (turbulences from bottom platform to cavity)
- Check valves of Pump leaking (Pump out of parameter set)
- Bacteria contamination of UPW system
 - filter blocked up to 4 bar crashed at 100 bar
- Handling of filter units (not activated for installation
 - crack at 100 bar pressure)
- Bubbles inside UP Water system (blockage / break of filter)
