# Summary of understanding of quench limit in 9-cell cavities using T-mapping and optical inspection

LCWS10 & ILC10 @Beijing  
(28/Mar/2010)

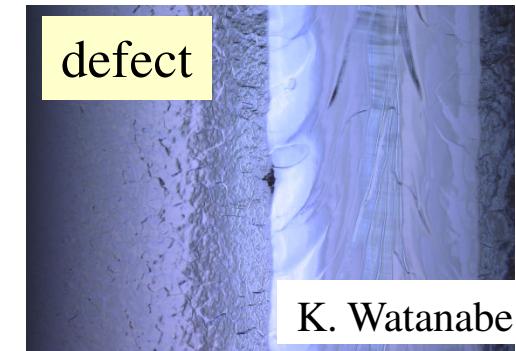
defect

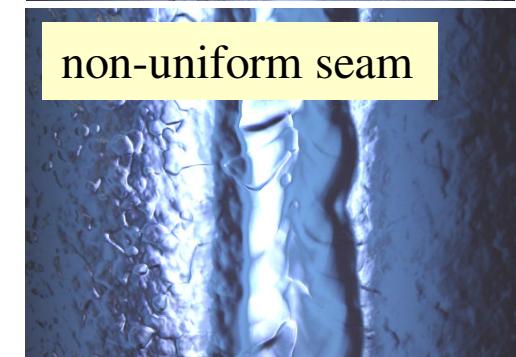
non-uniform seam

Suspicious spot  
Quality of EBW seam

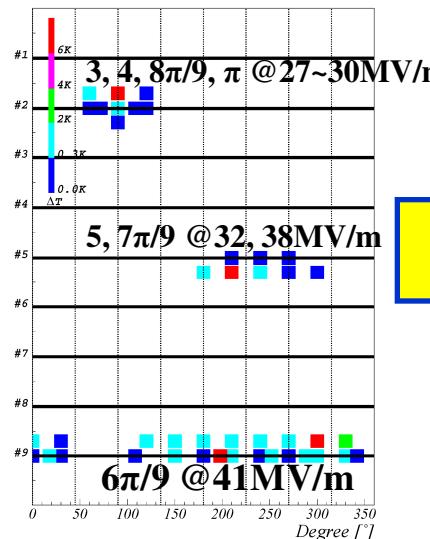
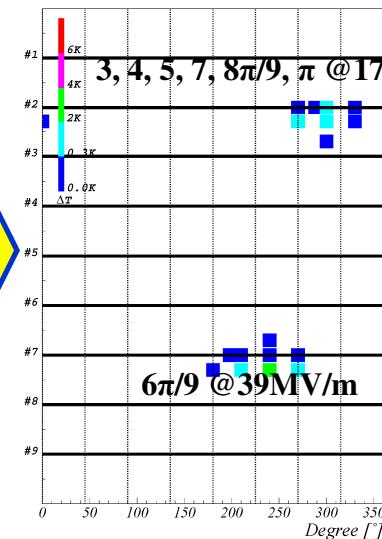
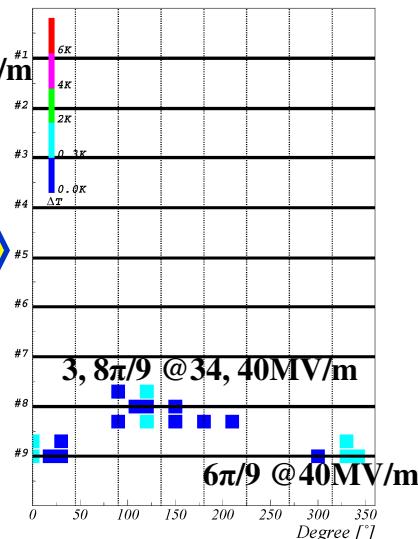
After the first V.T., local grinding was carried out and the pit at heating location was removed.  
After the second V.T., no grinding was done.

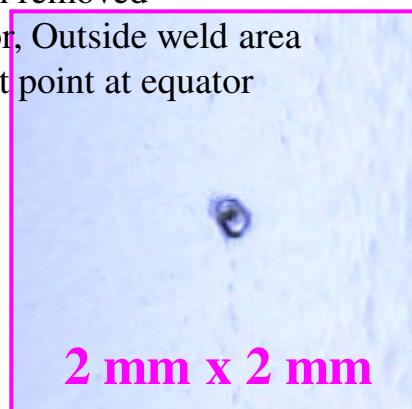
## cell #2, 86°@26.8MV/m (ellipse bump)

After 2<sup>nd</sup> V.T. 195 um removed

MHI-08, 2-cell equator, Outside weld area  
40mm away from joint point at equator  
T= 086deg. Upstream

2 mm x 2 mm

Ken will try to make the replica of this bump!

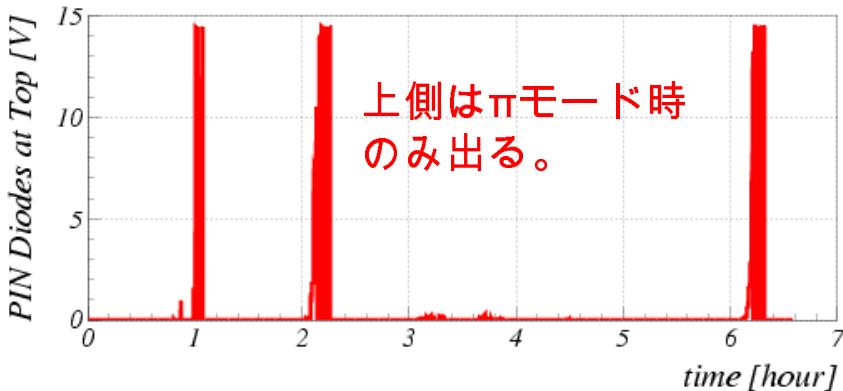
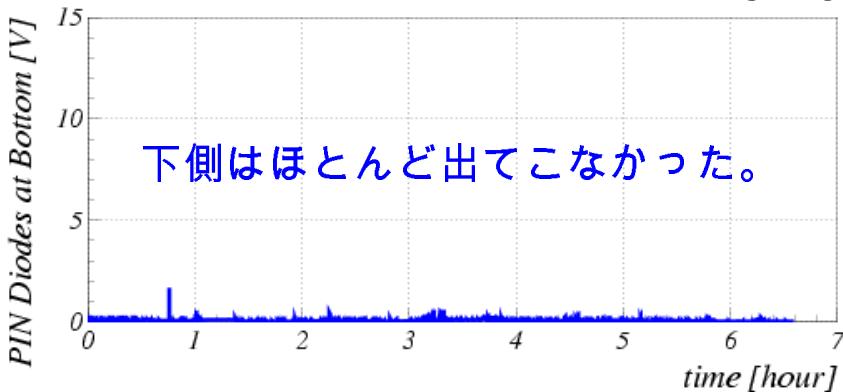
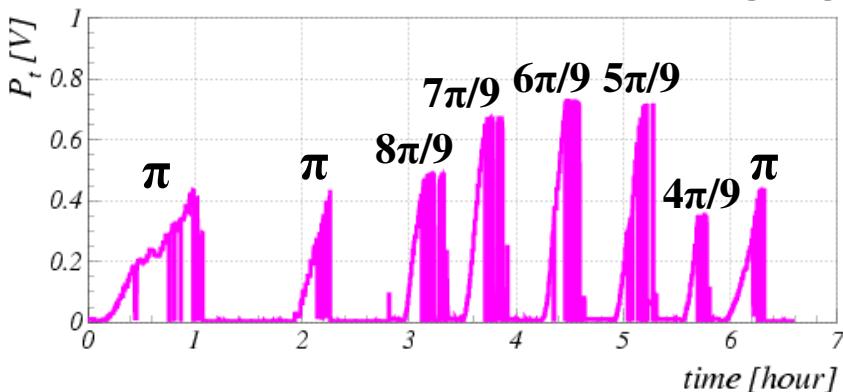
Comparison of X-ray Scatter for STF B.L.9 Cavity ('09/12/16)

1<sup>st</sup> power riseの途中から放射線量が急激に増加した。

放射線モニターとも相関がある。
