Explosive Events during V.T. in KEK

MHI-14

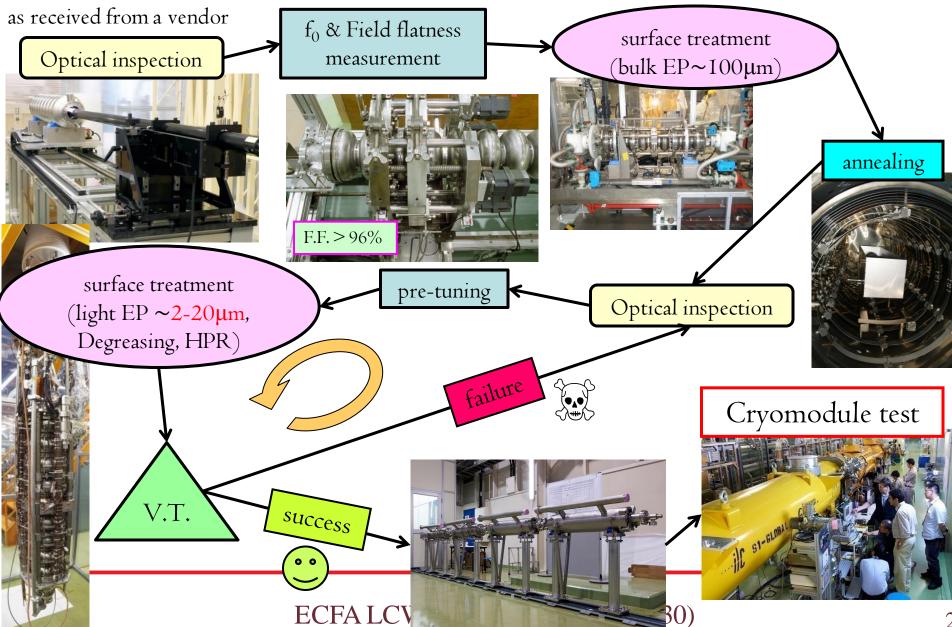
as received from a vendor Optical inspection Optical inspection

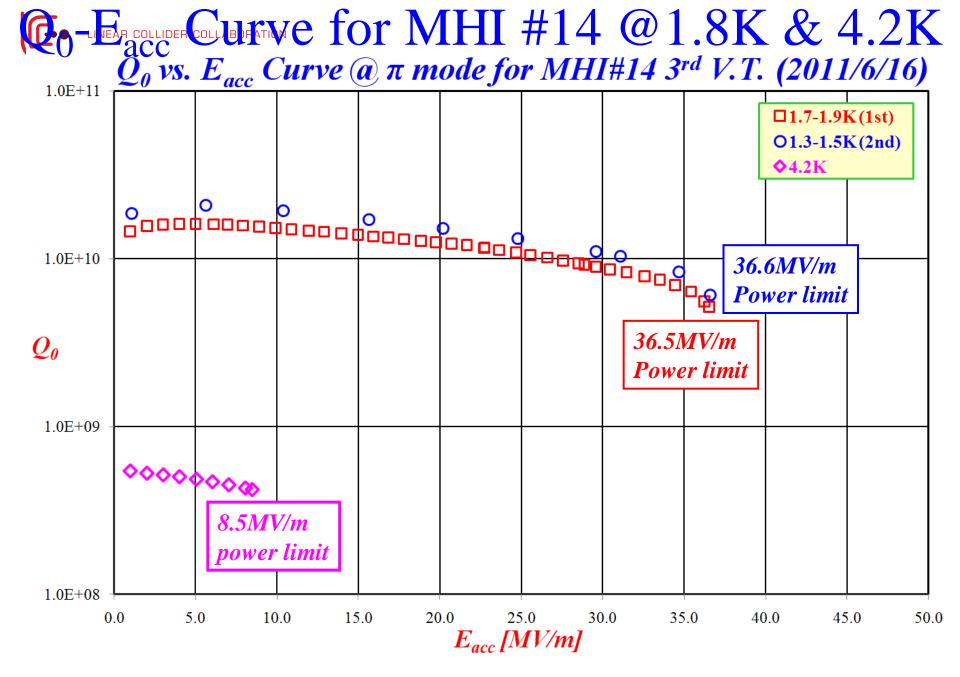
At this time, we **believe** this defect was problematic. Then, we did the local grinding for the removel.

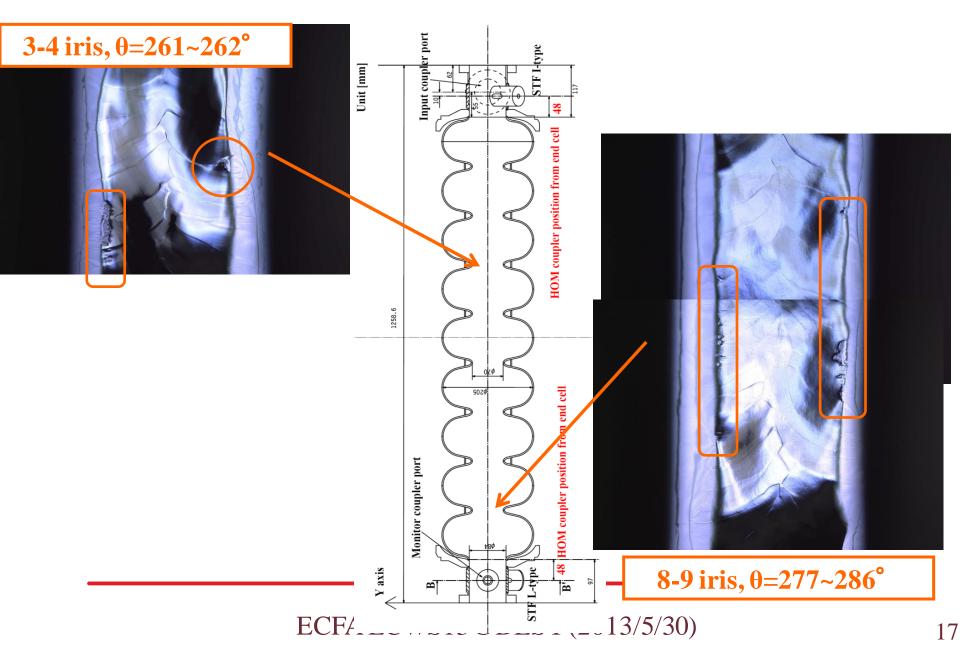
LINEAR COLLIDER COLLABORATION DE II: Defect on bead of Iris

When a cavity has such a defect at iris region, the heavy field emission certainly occurs.
