IPBSM

- Stability of the laser system -

Nobuhiro Terunuma

Feb. 12th 2014, KEK, 17th ATF2 project meeting

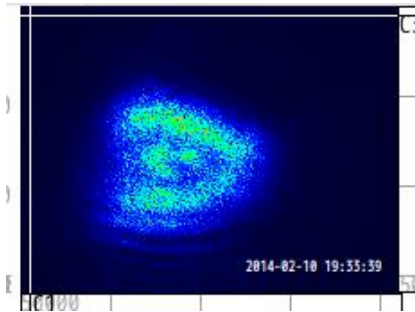
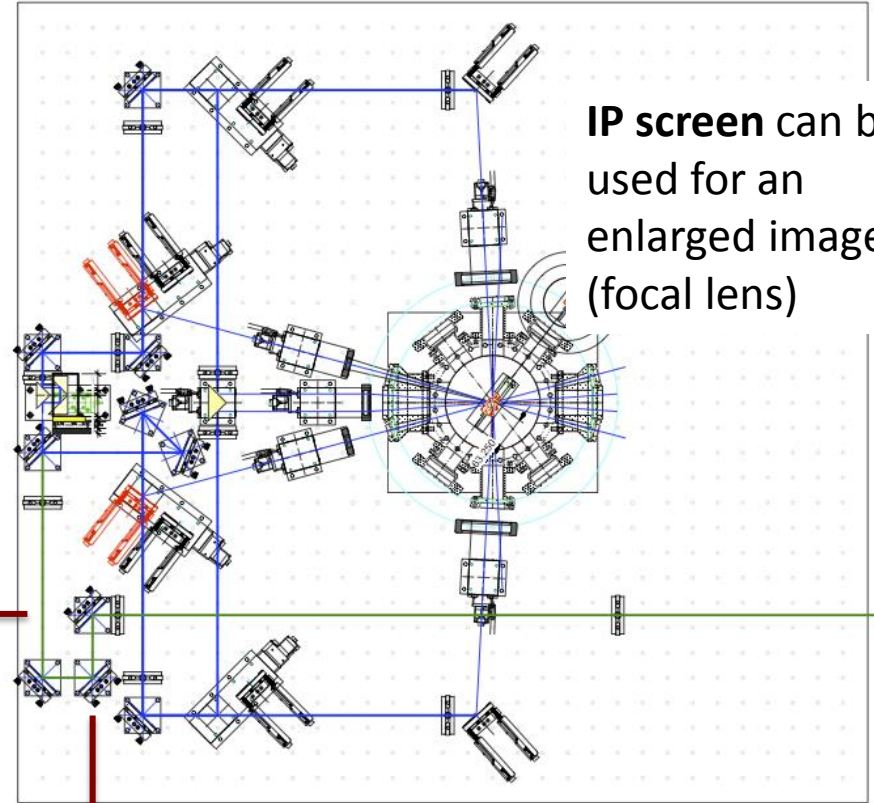
Laser image (CCD camera)

IP screen can be used for an enlarged image. (focal lens)

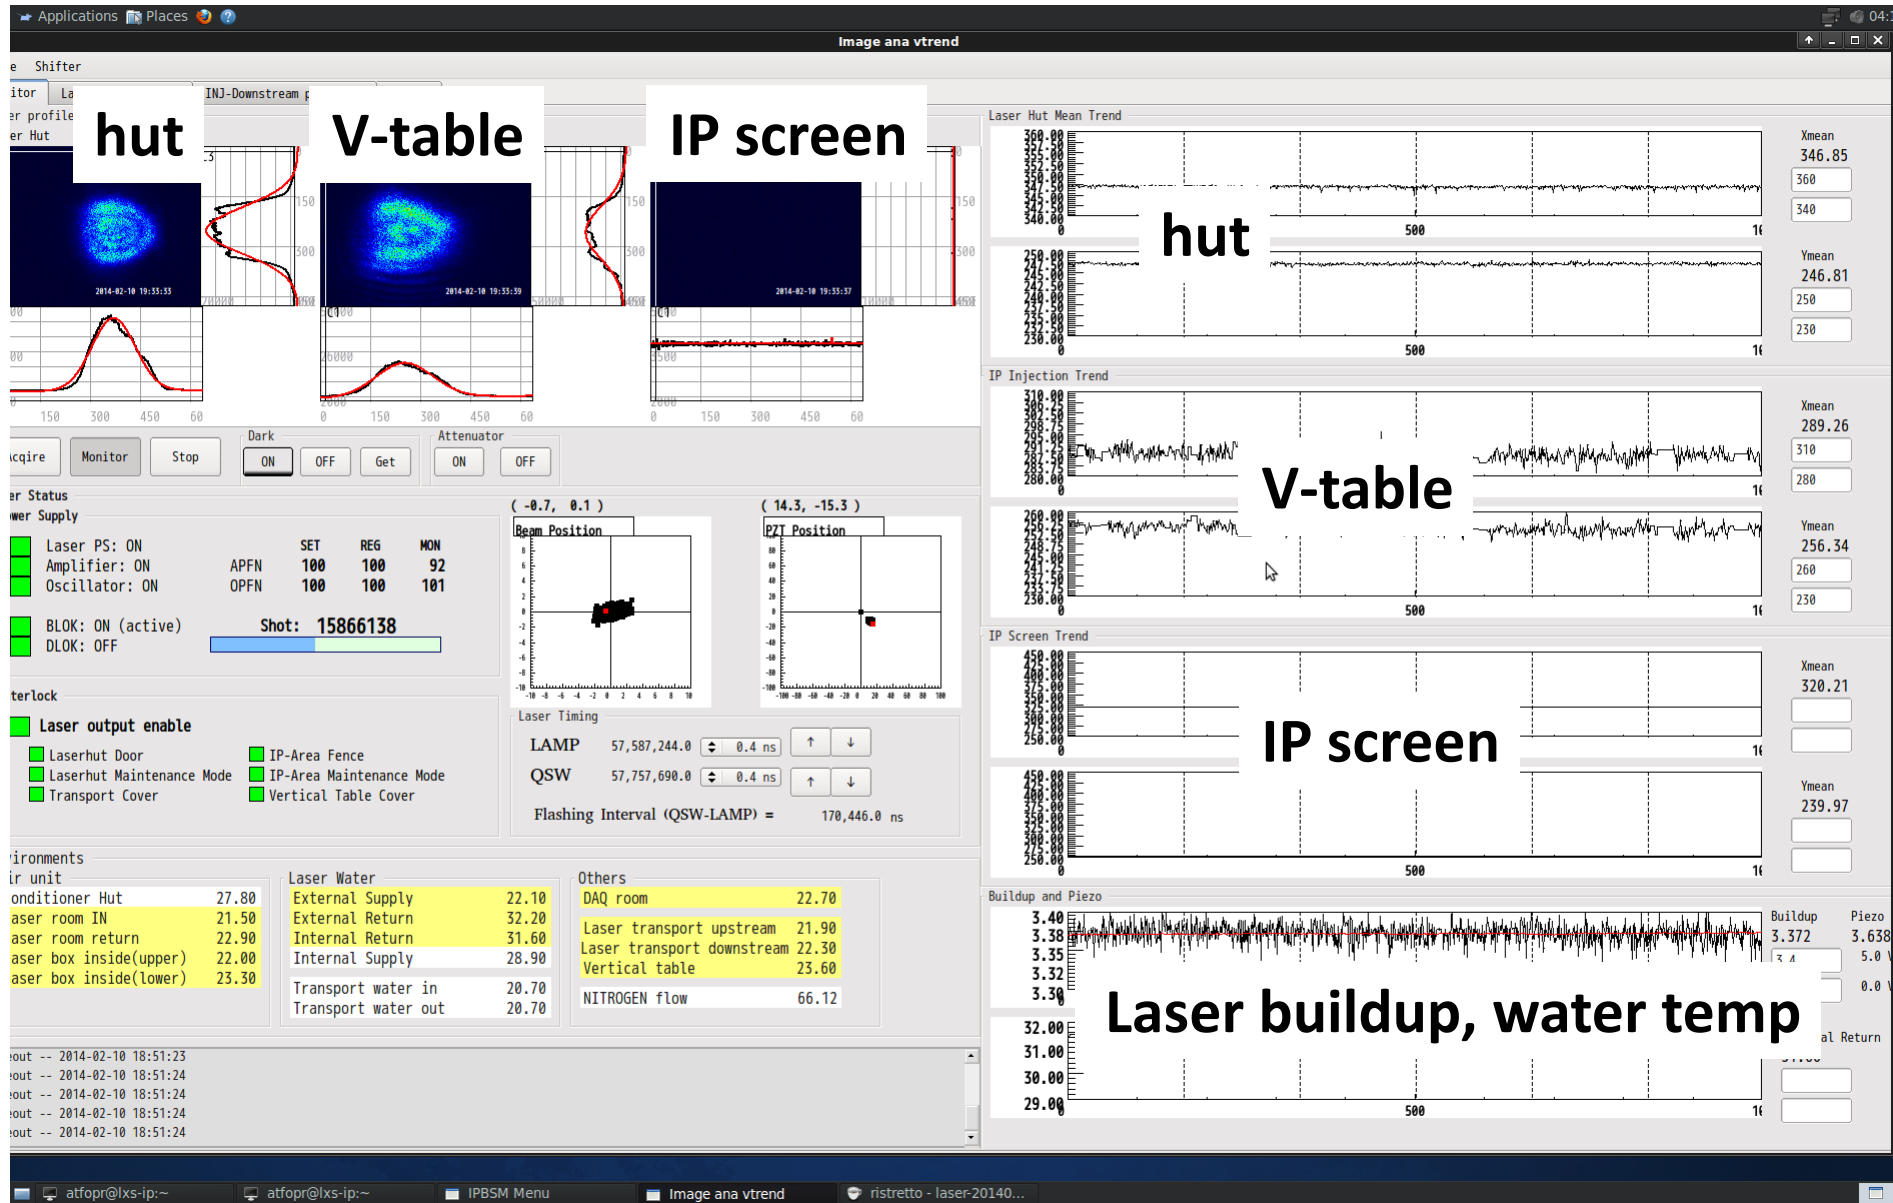
Stability monitoring of the laser profile

- **Setting of the laser oscillator is fine as expected.**
- **The cooling water unit is also working well and stale.**
- **Retuning the temperature controller of the Harmonic Generator (1064→532nm) reduced the amplitude of the drift about a half.**
- **Other laser components are passive and may not be candidates of the drift source.**
- We also discussed about other possibility and suspected the air turbulence in the laser transport.
