Kyoto camera upgrade

H. Hayano, 02242009 (Y. Iwashita, K. Watanabe, Y. Kikuchi)

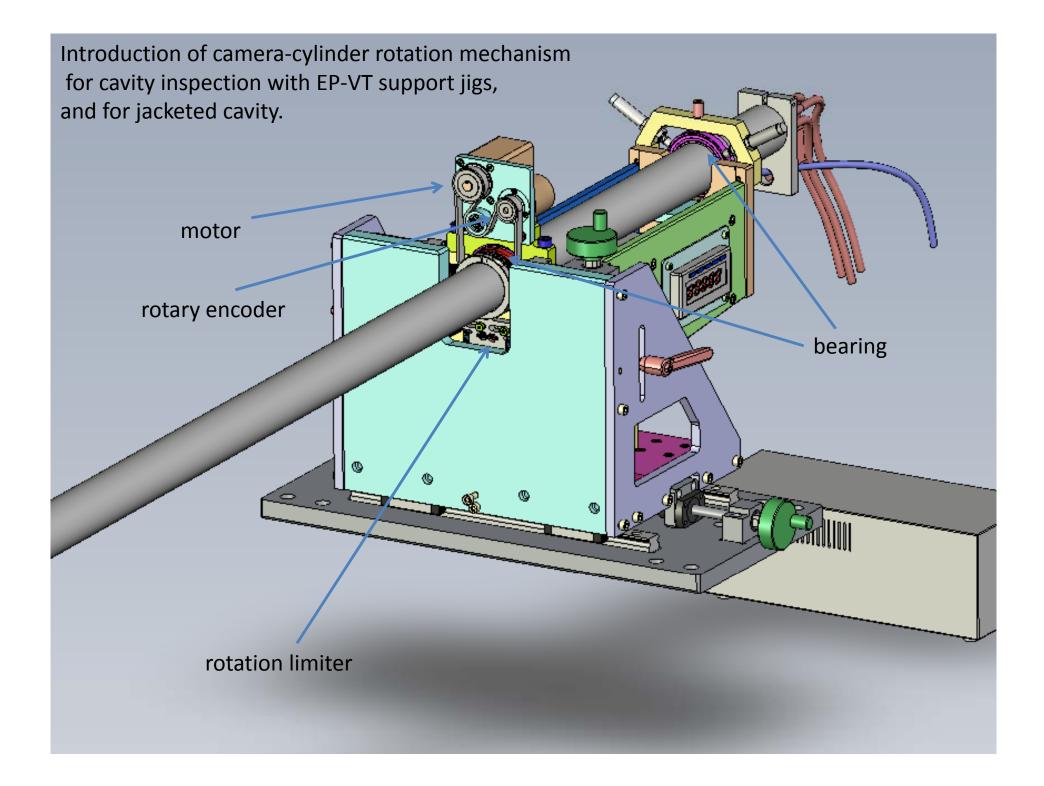
Upgrade under fabrication

(1)CCD camera upgrade from 5μm CCD pixel to 2.2μm CCD pixel camera.

(2) Lens upgrade

more magnification with more larger aperture.

(3) illumination upgrade

EL panel has limited life with more high voltage (for more brightness).

-> LED + light guide with scattered surface (twice more light).

~7 μ m/pixel \rightarrow targeting 3.5 μ m/pixel
