# AHCAL electronics.

## **Status Module Production an Power Pulsing**

AHCAL main meeting DESY, Dec. 10th, 2013

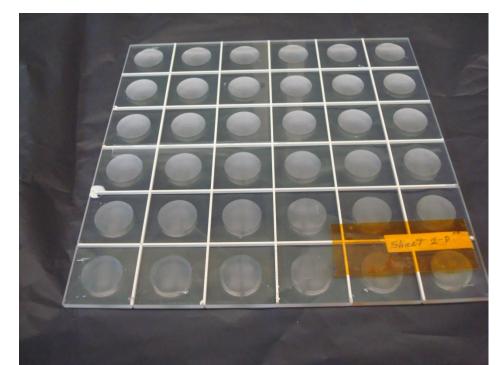
#### **Integrated Readout Layer**

- Uses HBU2 FE
- Hamamatsu MPPC mounted on small flex circuits
- Scintillator "Megatile" with 3 x 3 cm cells optically isolated with white epoxy
- Cells have a concave dimple improve the uniformity of the response and to direct light through hole in board onto MPPC
- Easier to assemble, does not need WLS optical fiber

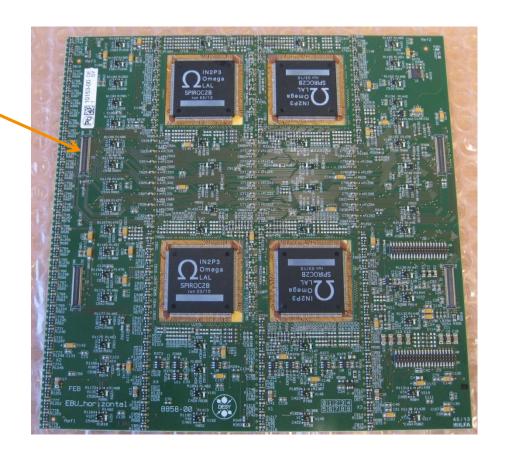
#### Scintillator ECAL – EBU horizontal

- 4 EBU\_horizontal produced.
- Horizontal scintillator orientation.
- Long flexleads needed at output, expected in Jan. 2014
- Survived Smoke-Test and worked (without bias/tiles) right out of the box ☺.
