# **Configuration of Beam/Service Tunnel in Asian Site**

**Atsushi ENOMOTO, Masanobu MIYAHARA  
KEK**

ECFA LC2013 DESY

May 30, 2013

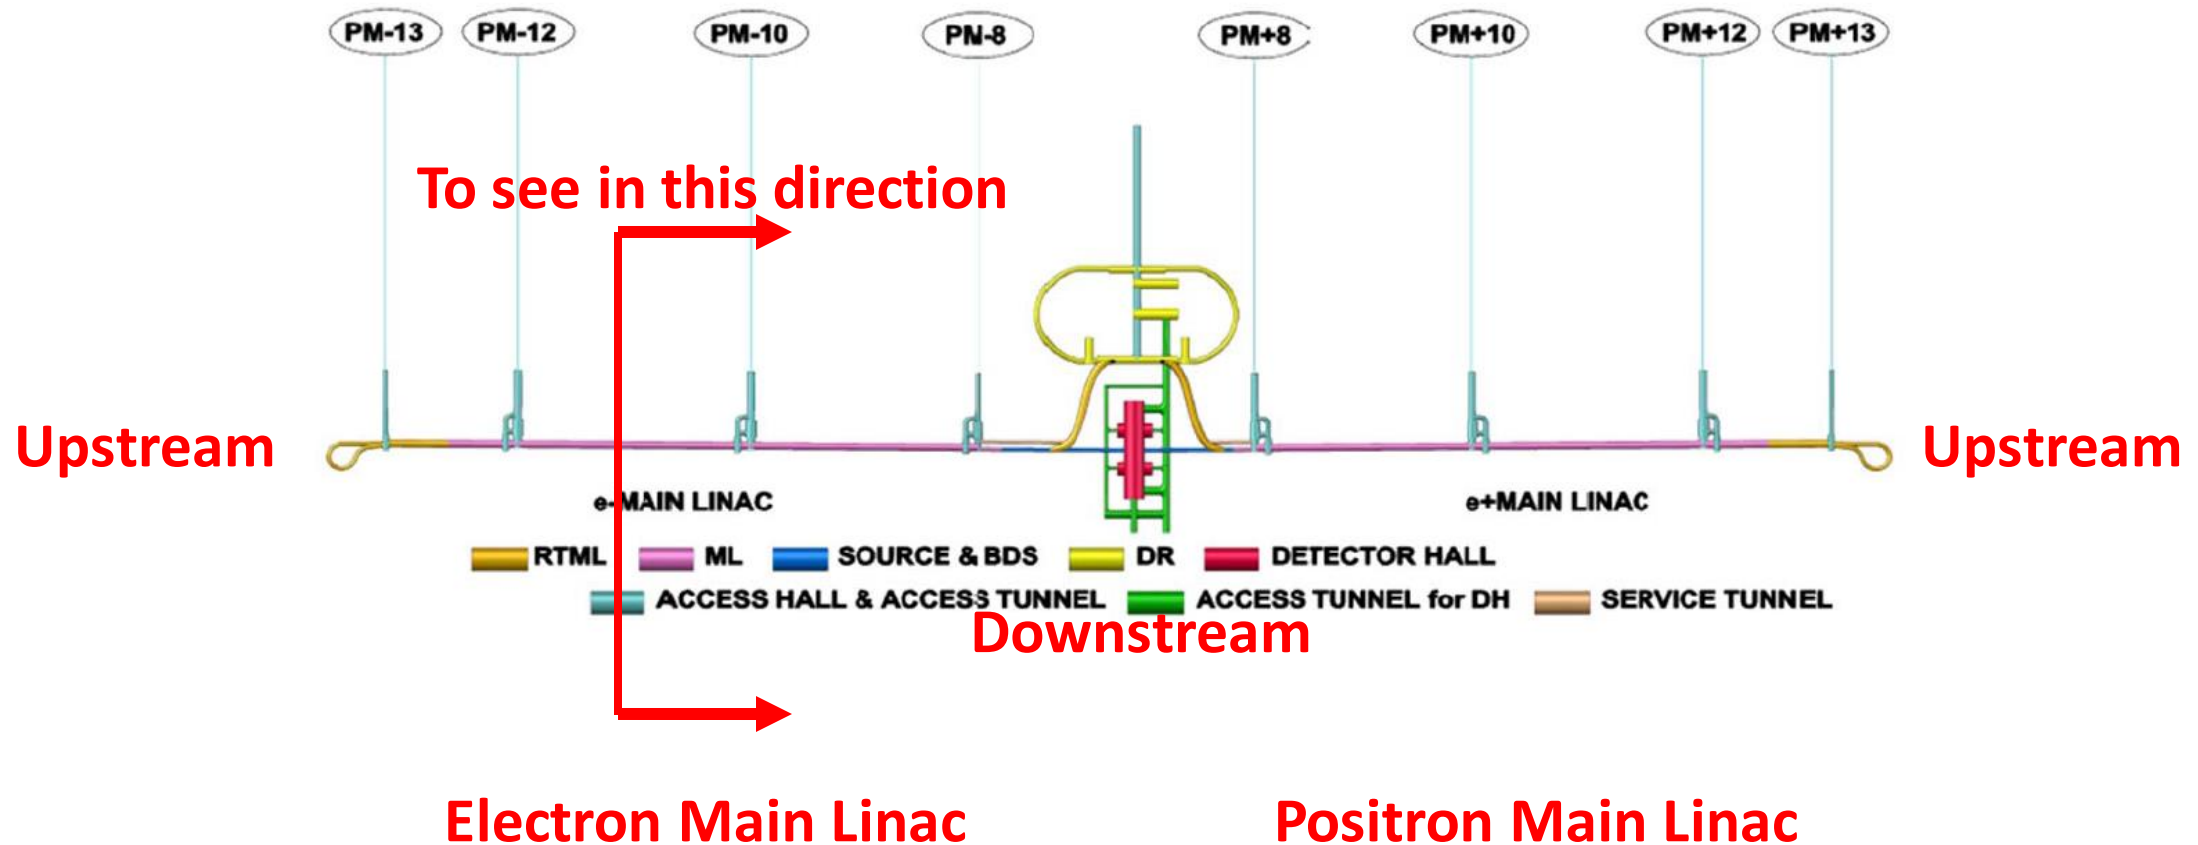
# Proposal for Direction To See Main Linac Section

Direction to see ML cross section should be kept always from upstream to downstream in the electron main linac.
